Manhole Inspection Summary

Manhole # S43UU_012MH

Insp Date: **2/12/07 8:13 AM**

Location Address: **2799 THE ALAMEDA**

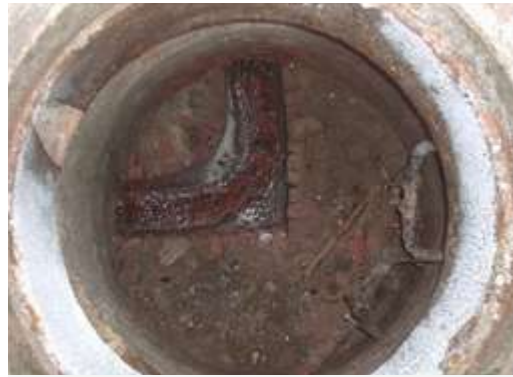
Top View

Corroded steps. Evidence of surcharge - Bench debris.

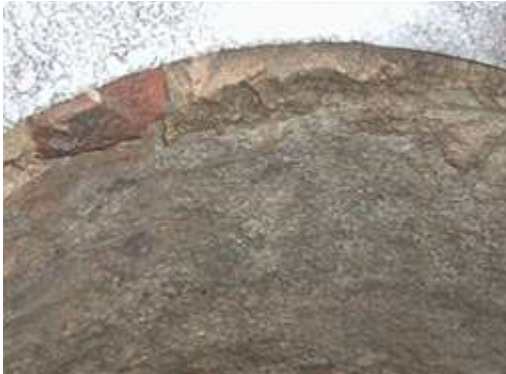
Defect

Chimney / Frame Adjustment ☒ Exists Material: **Brick** ☐ Parged Height: **3** (in.)

Condition: ☐ Sound ☐ Cracked ☐ Root Intrusion ☐ Loose Brick ☒ **Deteriorated**

Infiltration: ☐ None ☒ **Joint** ☐ Cracks ☐ Mortar ☐ Roots ☒ **Wall**

Adjustment deterioration and infiltration.

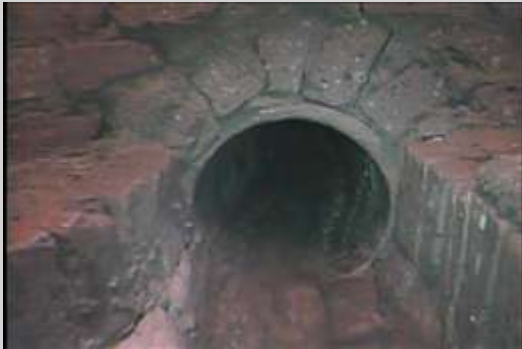
8 in. Circular Gravity Sewer Pipe Out @ 12 O'Clock

Barrel deterioration and infiltration. Channel deterioration.

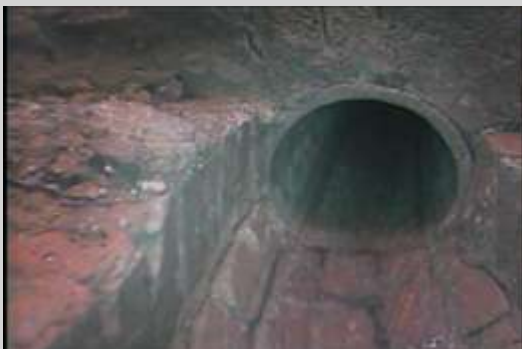
8 in. Circular Gravity Sewer Pipe In @ 9 O'Clock

Barrel infiltration and deterioration. Channel deterioration. Bench deterioration.
